Removal of the Big Rapids Dam Remnant: An Environmental Assessment

Summer 2000

Environmental Management Studies Center

Ferris State University
Big Rapids, Michigan

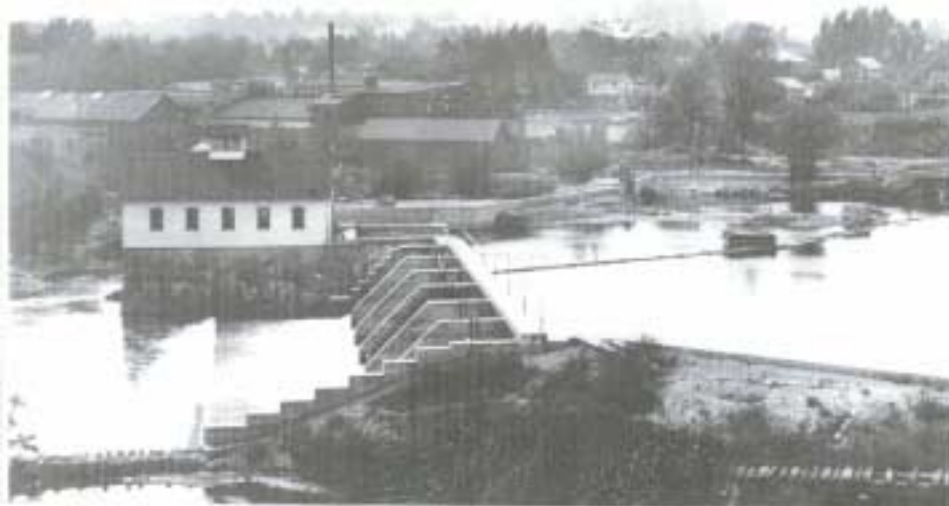
Figure 1:

Original hydroelectric dam structure. Photo taken facing west (46).

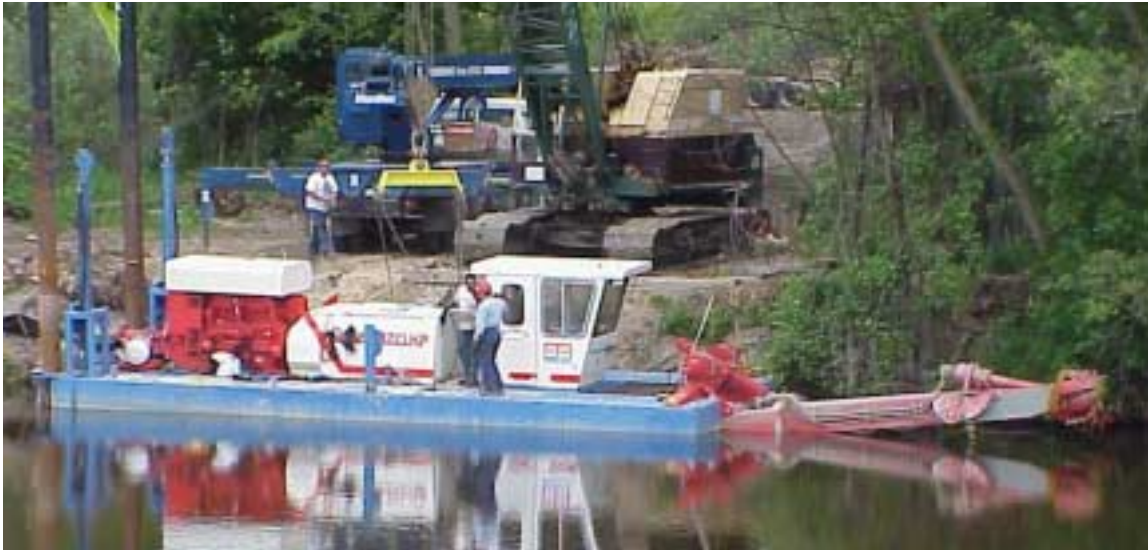
Figure 3:

Ellicott Intl. MudCat™ Dredge, Photo taken facing east, June 28,2000 (46).

The resulting excavation will create a depression on the river bottom that will serve as a sediment trap, collecting re-entrained sediment before it can travel downstream (25). This dredging technique is performed by a specifically designed barge, called a "MudCat™", mounted with an auger-type vacuum that rotates, drawing in water and sediment (Figure 3).

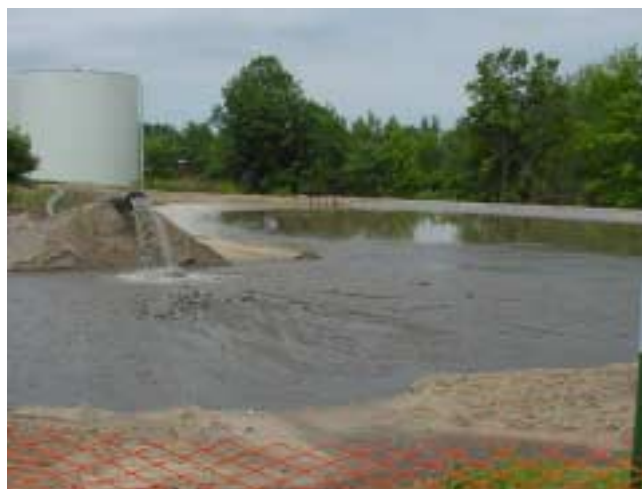
Figure 4:

Sediment collection basin. Photo taken facing northeast, July 6, 2000 (46).

The sediment is then pumped through a 12-inch diameter pipe approximately 1,200 ft. downstream to the collection site. From this point, the dredged material is discharged to a collection basin where sediment is allowed to settle and water is drained back into the river. Bails of straw have been placed on the bank of the river to filter the water runoff prior to its return. The collected sediment will then be removed at the completion of the construction phase. If possible, the City would like to treat the sediment as a resource and sell it for road fill, etc. (Figure 4).

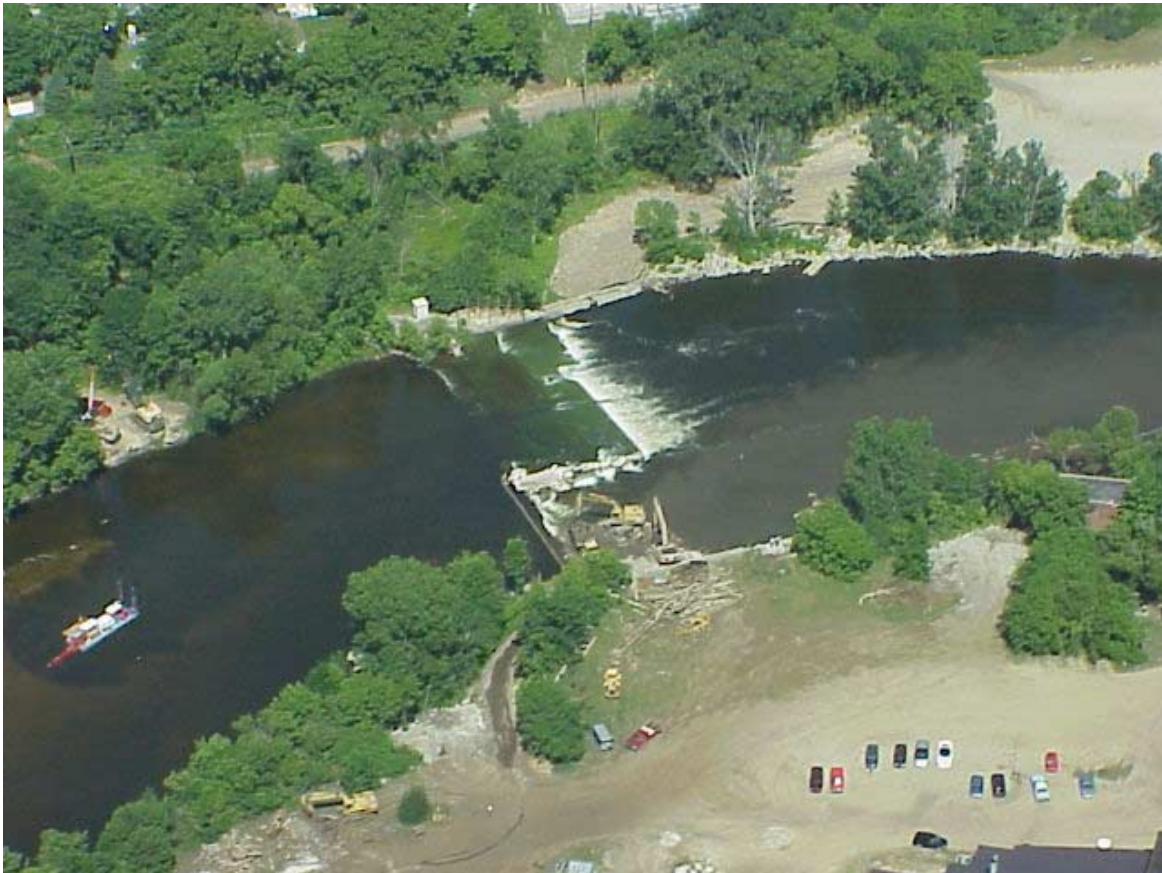
Figure 5:

Aerial photo of remnant removal area with diverting structure and MudCat™ in place, June 29, 2000 (46).

While proceeding with sediment removal, the first step in the dam remnant removal project has begun. This step is to construct a water diverting structure that will allow the demolition process to be completed. The water diversion and subsequent demolition will be completed on one section of the dam at a time (Figure 5). Water will be diverted from the west side of the dam first, allowing for its demolition. The barrier will then be removed and placed on the east side of the remnant to complete the demolition. The proposed course of action is to use large industrial pulverizing machines, similar to a “jack hammer”, to break the concrete from the dam into boulder like pieces 10” to 16” in diameter. Waste concrete will have the metal reinforcing rods removed, and will be used as retaining material for the riverbanks and fill for the scoured river bottom in front of the dam remnant to prevent erosion (25).

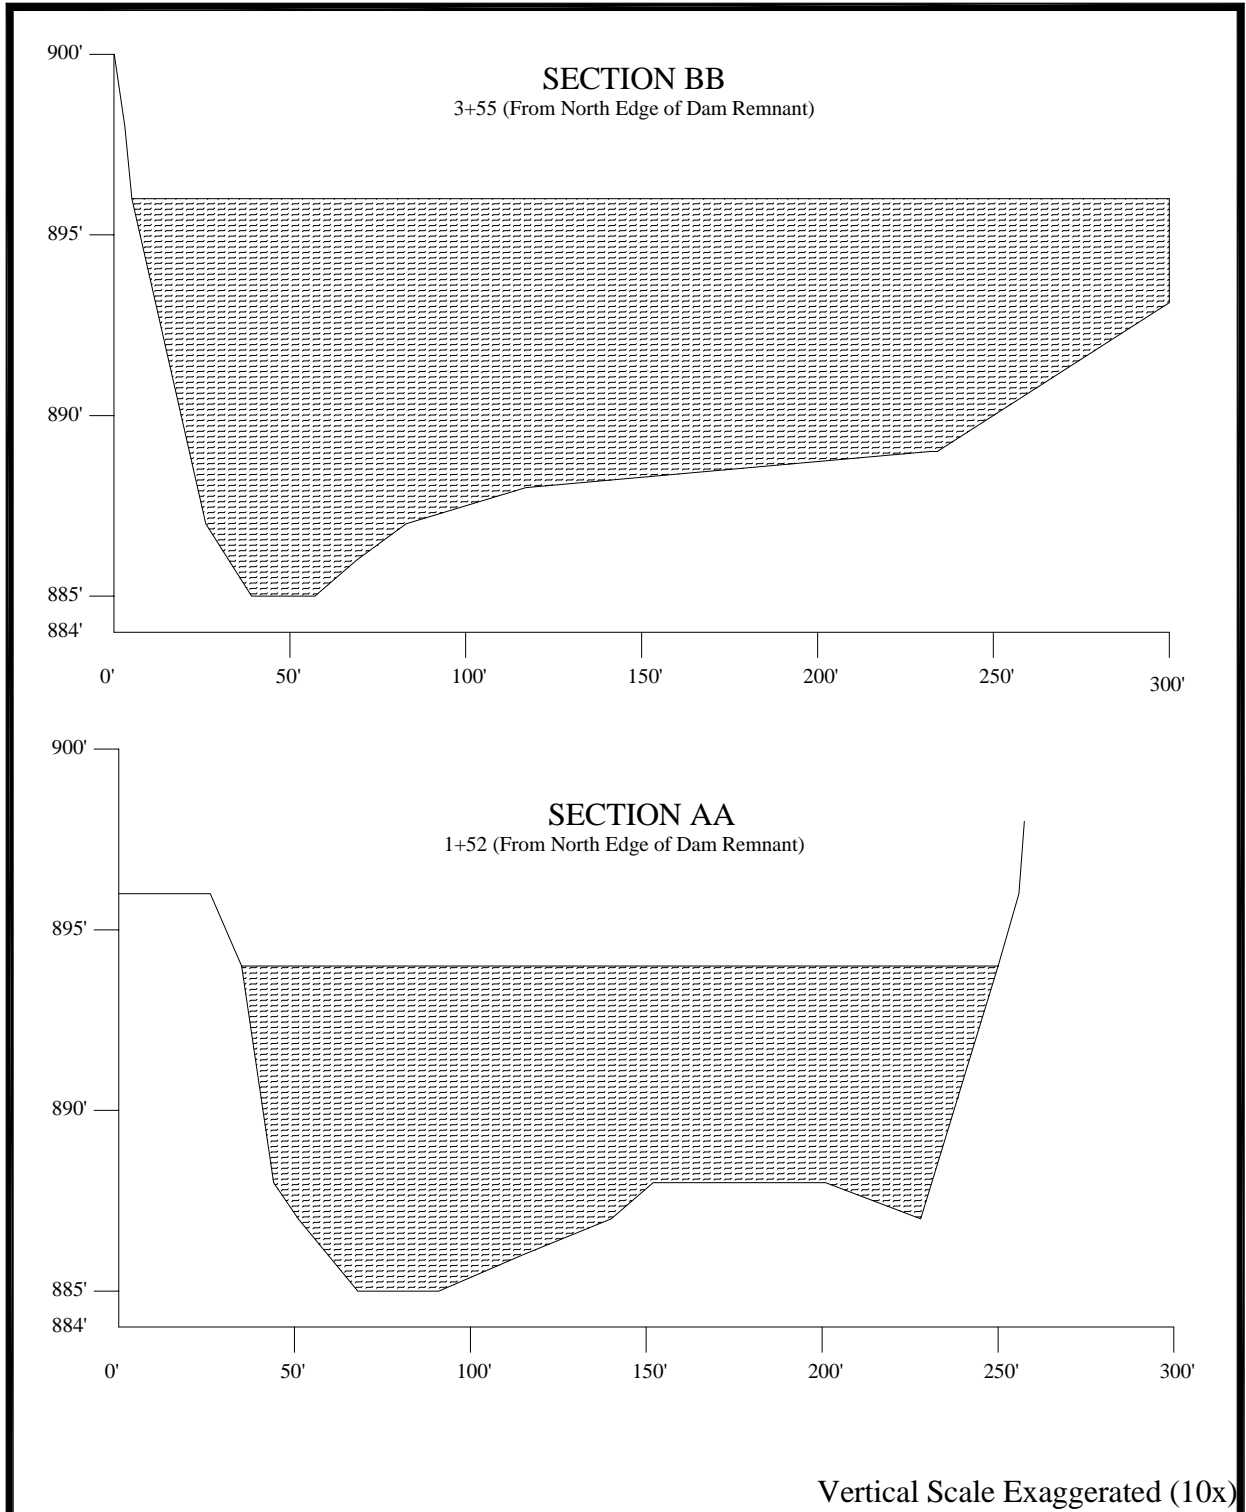
Figure 12:

Existing Cross Sections of Muskegon River Bottom

remnant. The maps illustrate widths and topography of the river bottom at the cross section areas. It should be noted that the vertical elevation scale shown on the four cross sections is exaggerated 10 times to emphasize a contrast in depth (Figures 12, 13).

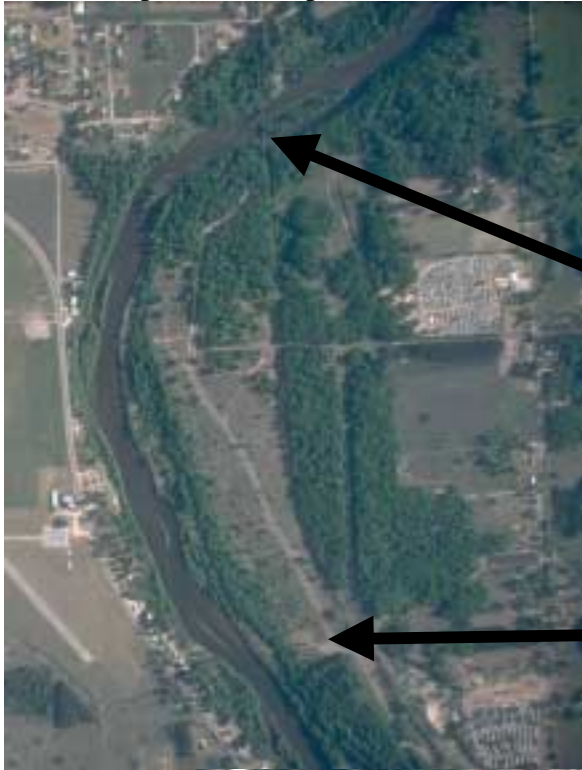
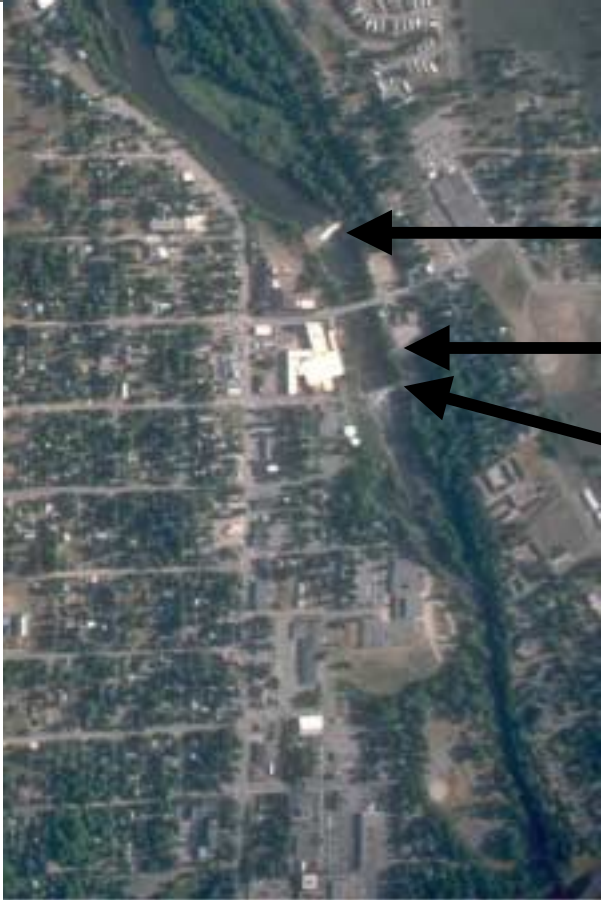
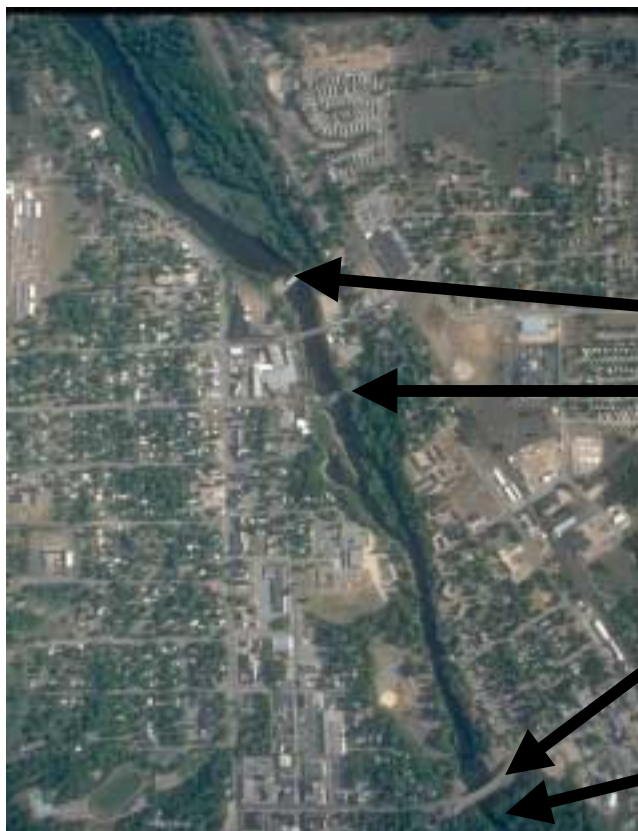
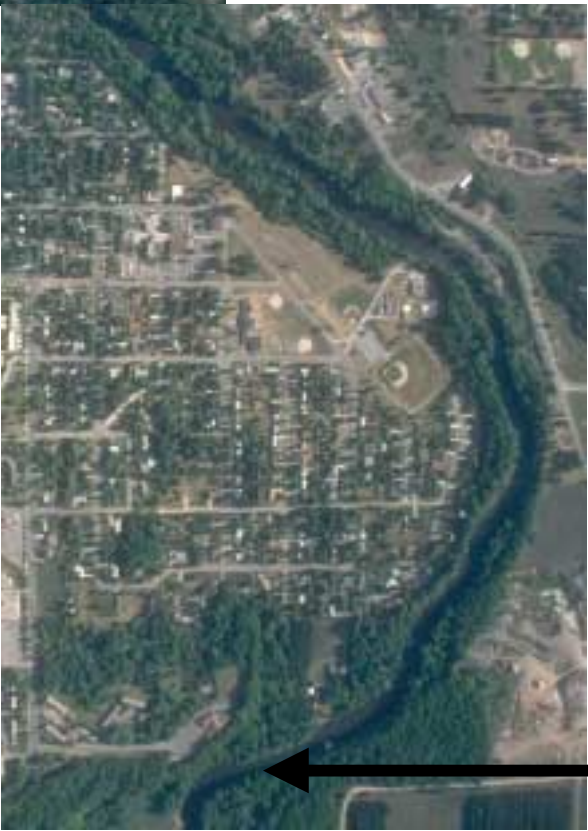
Figure 15: Sample Point Map

Figure 15: Sample Point Map, Continued

Sample Site 1: This site was chosen to obtain data for that part of the river flowing north of an island at White's Bridge that divides the Muskegon River. The water quality of the river may vary on either side of the island, therefore, a sample site was chosen on each side.

Sample Site 3: This site was chosen because any major changes due to sediment loss or erosion caused by the dam remnant removal would be seen at this site. The site is approximately 3500 feet upstream of the dam remnant, and is the area where most ecological and water quality changes are anticipated following the remnant removal. This is also an area of high traffic (canoe removal and fishing) and heavy human activity may negatively impact the river at this point.

Sample Site 5: This site was located at Maple Street Bridge and was selected to detect changes that may be caused by the dam remnant removal or general use of the river, such as tubing or swimming.

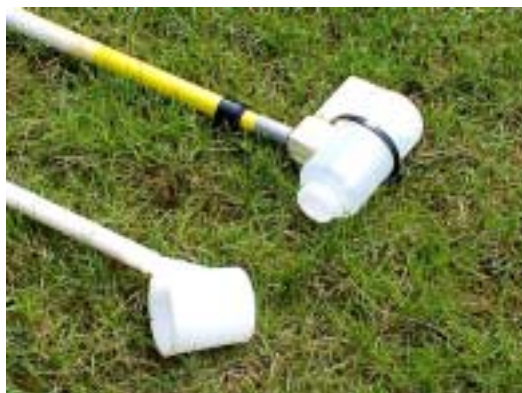
Figure 17: Water Sample Devices

Top: Swing Sampler
Bottom: Dipping Sampler

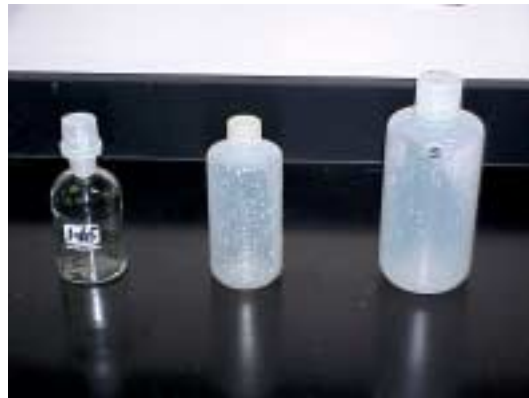
Figure 18: Sample Bottles

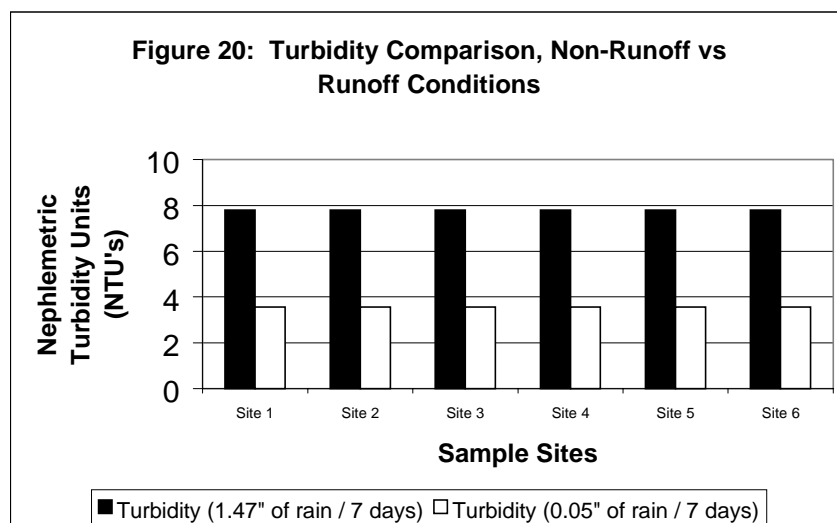
All turbidity data was obtained from the operators of the City of Big Rapids Water Treatment Plant (WTP), who record this information daily. Turbidity data is expressed in Nephelometric Turbidity Units (NTU) and is located in Figure 19. During the study turbidity values progressively decreased, as did the amount of precipitation the area received. Figure 20 is a graph representing non-runoff vs. runoff conditions for turbidity values. Lower precipitation causes suspended solids in rivers to decrease, which, in turn causes the turbidity to decline.

Figure 19: Turbidity values

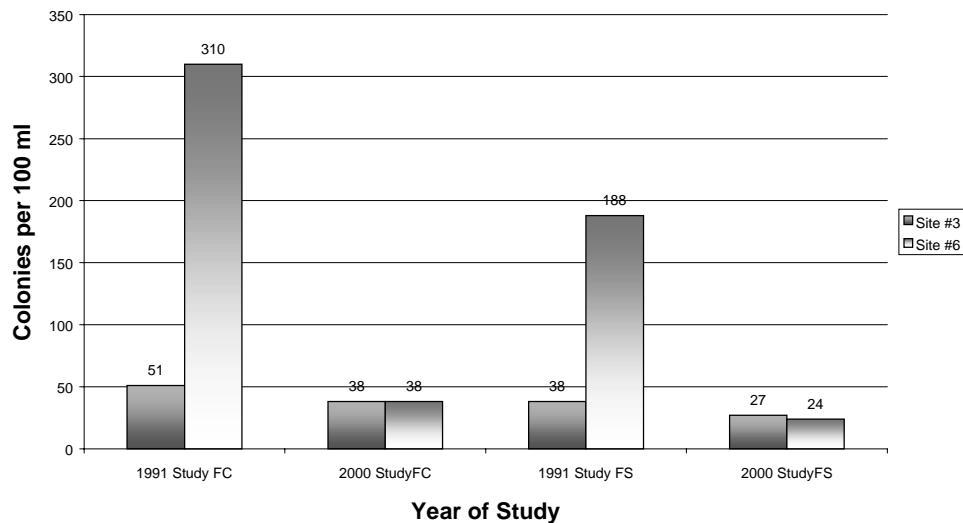
Figure 26: 1991/2000 Fecal Coliforms & Fecal Streptococcus Comparisons

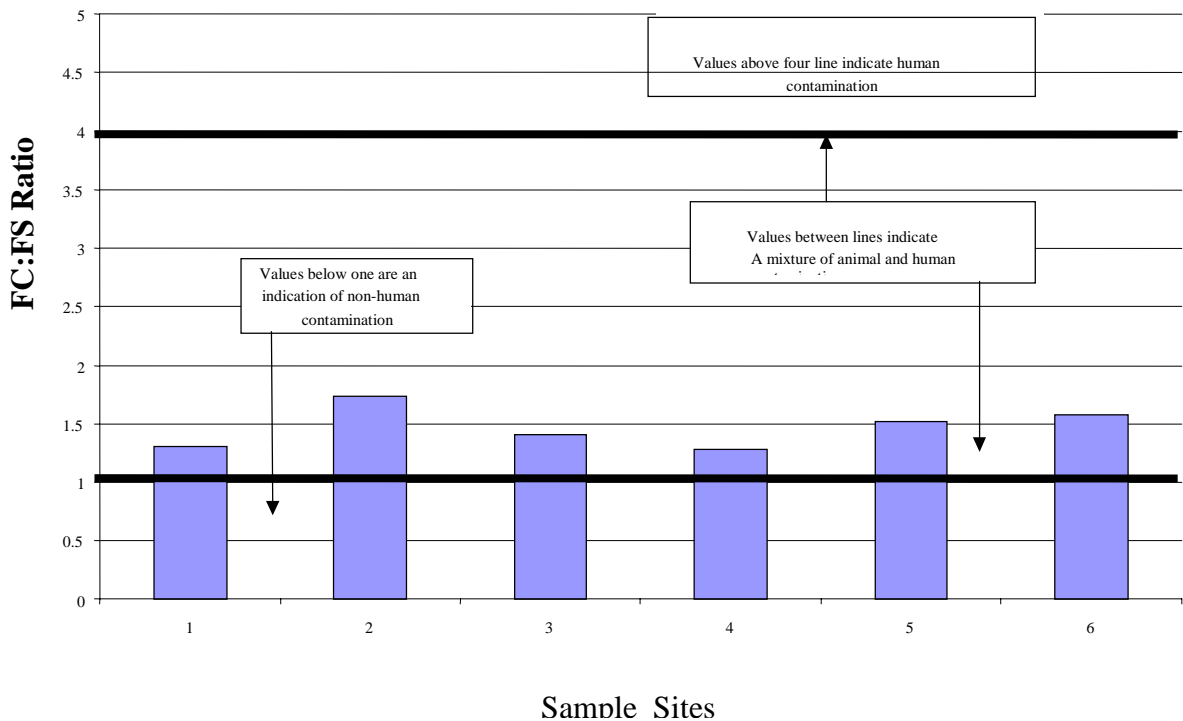
Figure 27: Fecal Coliform:Fecal Streptococcus Ratio

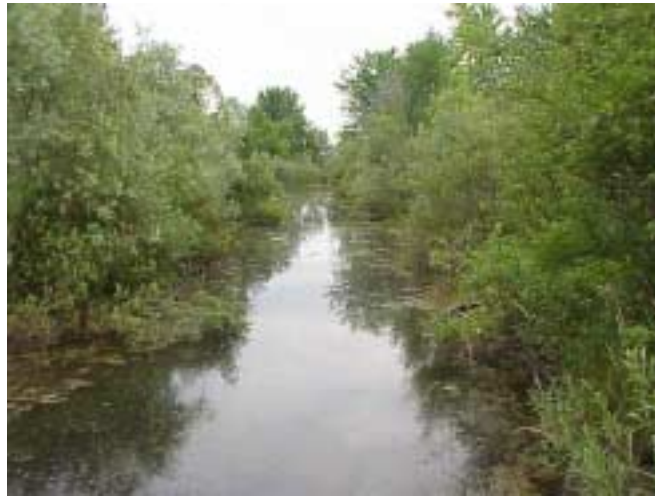
Figure 32:

The oxbow, with willow and tag alder. Photo taken along the nature trail at Northend Riverside Park July 20, 2000.

Plant zones usually found in ponded water were found in an oxbow 3,600 feet upstream of the dam remnant on the east side of the river. The three zones are an emergent zone which includes cattail (*Typha latifolia*) and bullrush (*Scirpus sp.*); a floating-leaved zone consisting of plants which float on the waters surface such as duckweed (*Lemna sp.*); and a submergent zone in which the plants are completely underwater (4). Shoreline vegetation included reed canary grass (*Phalaris arundinacea*), willow (*Salix babylonica*), and tag alder (*Alnus rugosa*) Figure 33 lists some of the plants found in oxbows and along the banks of the river.

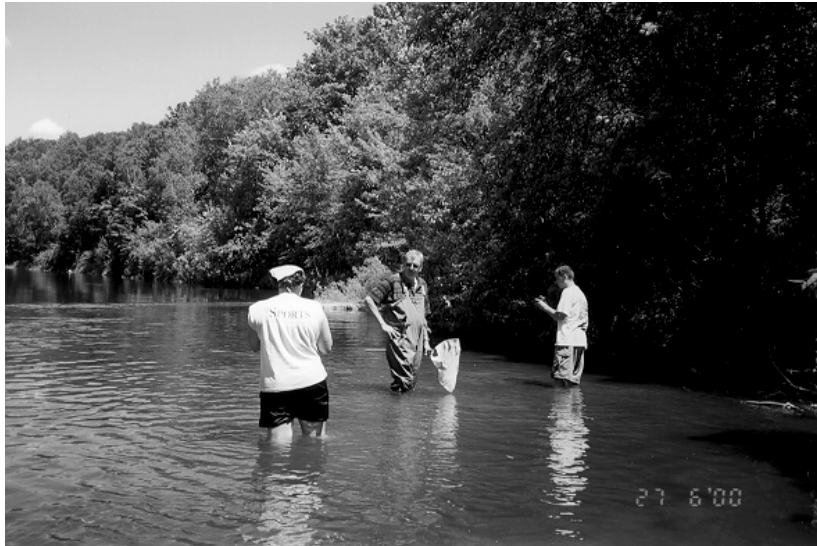
Figure 39:

Professor Beetley and students conducting insect survey above White's Bridge on June 27, 2000.

In order to determine the species and abundance of aquatic insects present in the study area, an aquatic insect survey was completed in four different locations on the Muskegon River by randomly lifting up ten 5-6 inch diameter rocks in each location and counting the number of aquatic insects present. Site 1 was a rocky river bottom with calm water located above White's Bridge. Site 2 was a riffled cobble river bottom with faster water located directly beneath Whites Bridge. Site 3 was a sandy bottom with sparse rocks upstream of White's Bridge on the east bank. Site 4 was an area of sparse rocks and mucky bottom at Northend Riverside Park. Sites 3 and 4 are silty, which may block the respiratory membranes of aquatic insects. Figure 40 displays the sample sites chosen for the aquatic insect survey.

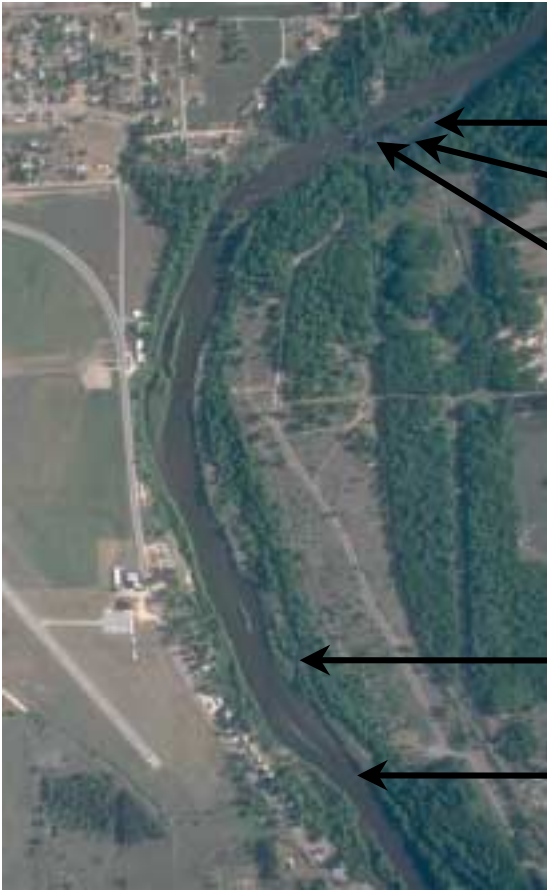
Figure 40: Natural History Field Study Areas

Insect Sample Site 3

Insect Sample Site 1

Oxbow

Insect Sample Site 4
